Storm Water Construction General Permit Inspection Report

WDID # 5S03C337319

Pine Grove Bluffs

1/24/2009

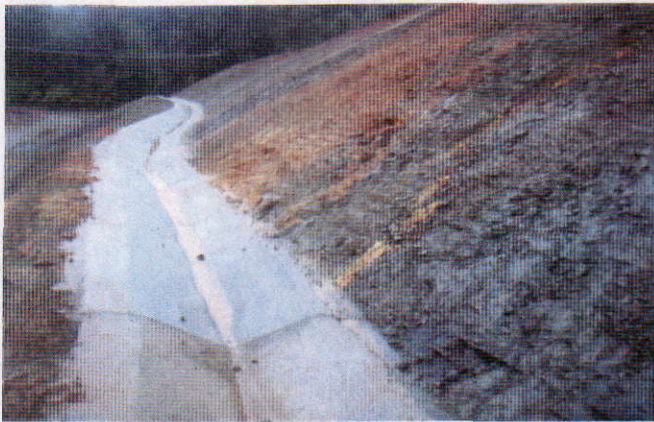
Figure 1: One of the many areas where soil is slumping on the steep slopes on the northern side of the project

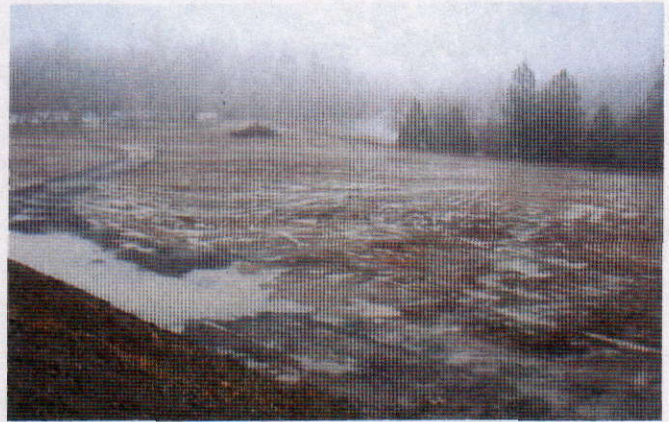
Figure 2: Overview of one portion of the project

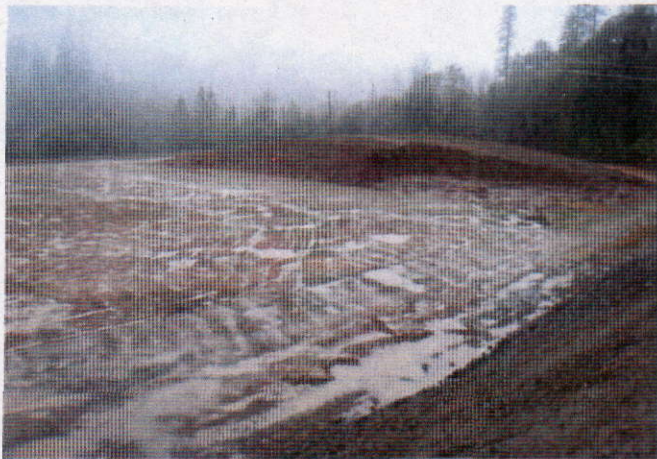
Figure 3: Overview of another portion of the project

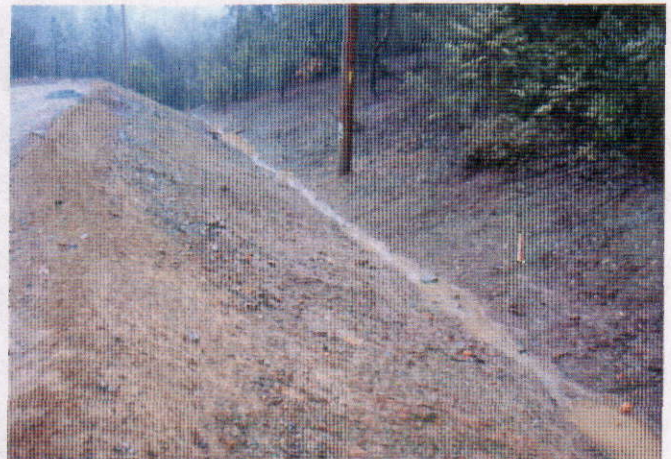
Figure 4: Lack of an effective combination of erosion and sediment control BMPs

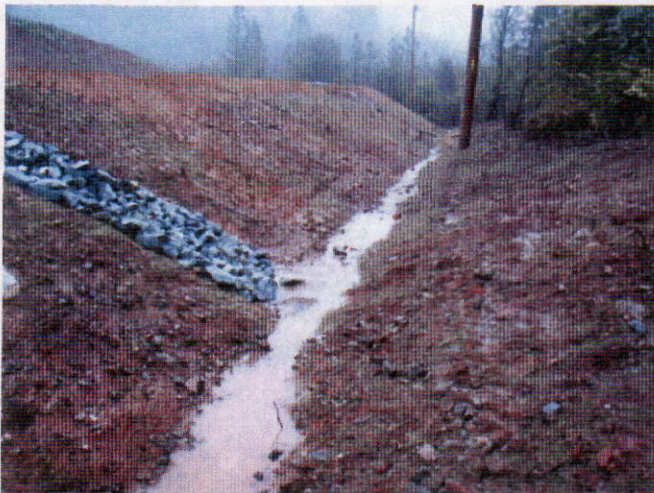
Figure 5: Lack of effective BMPs on the slopes and lack of BMPs in a defined drainage channel

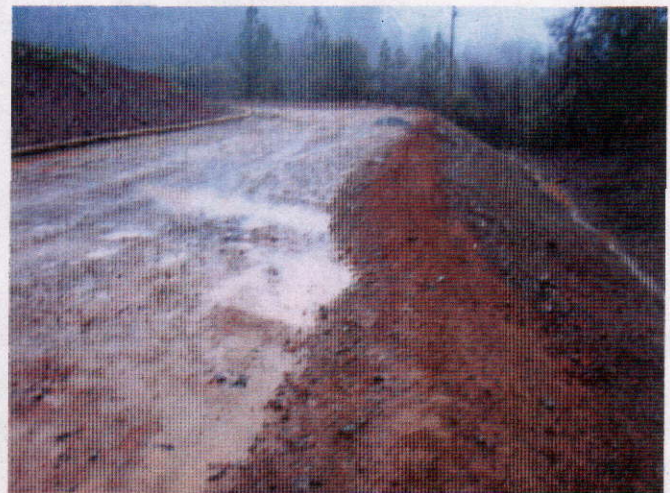
Figure 6: Lack of an effective combination of erosion and sediment control BMPs

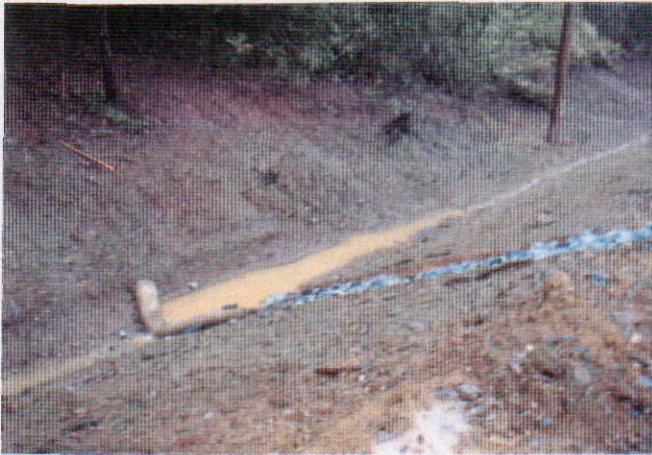
Figure 7: Lack of an effective combination of erosion and sediment control BMPs

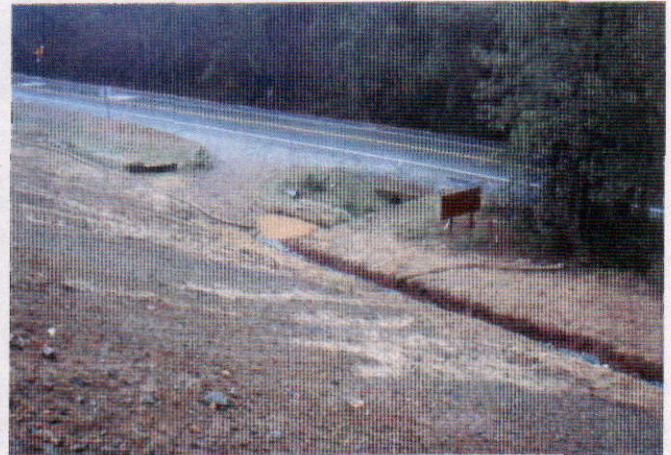
Figure 8: Partially protected slope Note: the turbid discharge leaving the site which flows directly under the roadway and into the creek

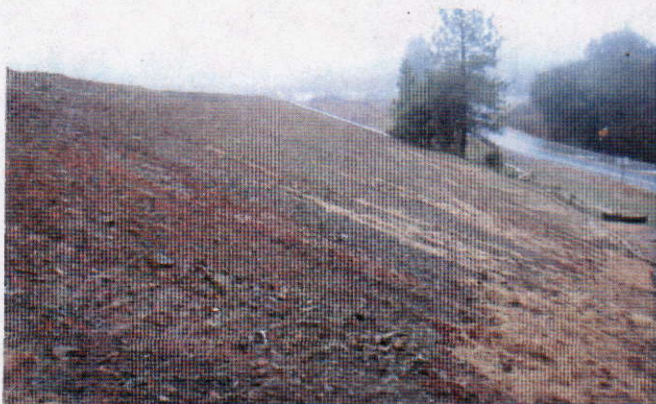
Figure 9: Poorly protected slopes

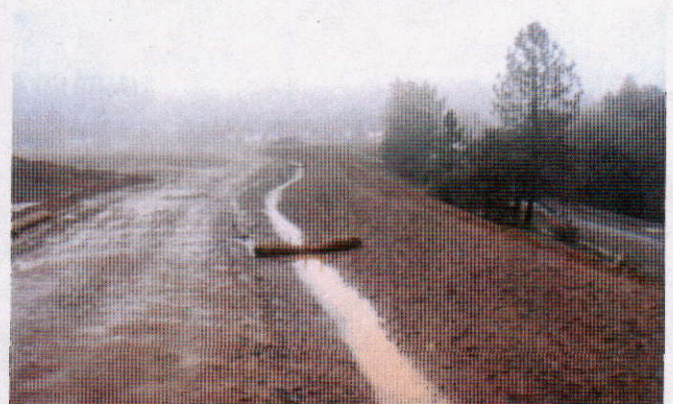
Figure 10: Lack of an effective combination of erosion and sediment control BMPs on a portion of the project

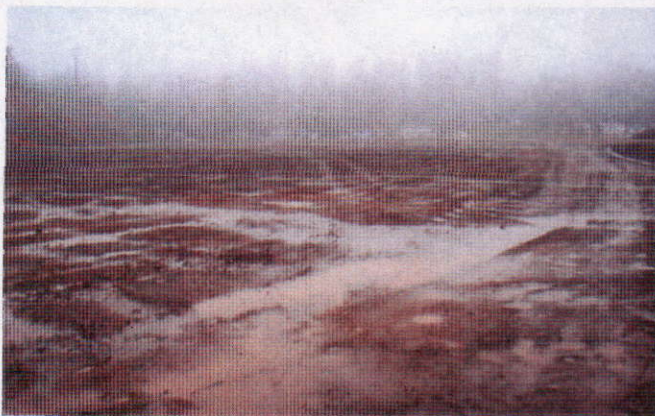
Figure 11: Lack of an effective combination of erosion and sediment control BMPs on another portion of the project

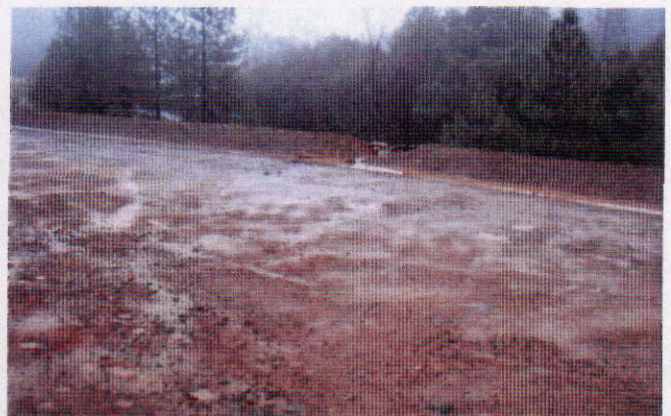
Figure 12: Lack of an effective combination of erosion and sediment control BMPs on still another portion of the project

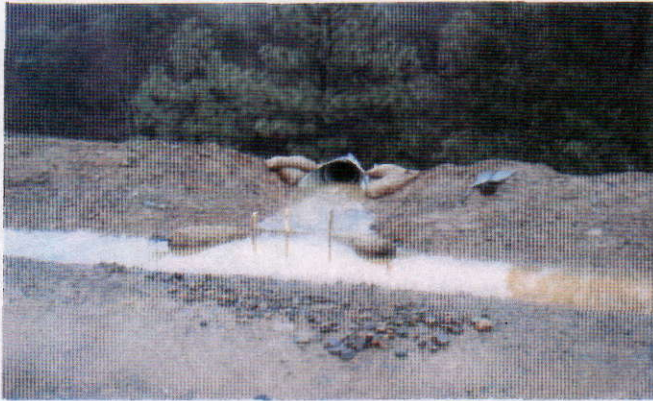
Figure 13: Inadequate BMPs at a location where storm water flows from the site into a down drain which directly flows under the roadway and into the creek

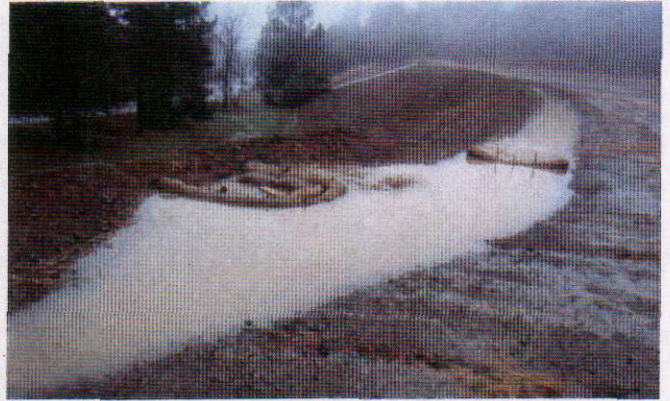
Figure 14: Inadequate BMPs at another one of the discharge areas

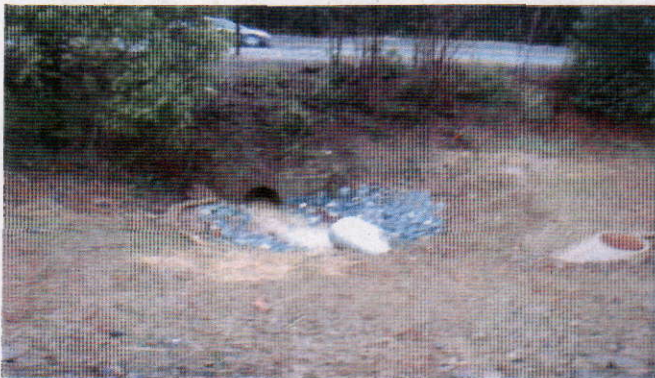
Figure 15: Storm water discharge from the site entering the culvert which flows under the highway and directly into the creek

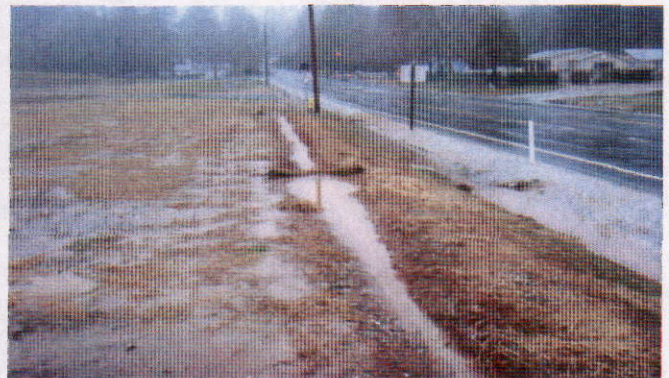
Figure 16: Storm water flowing on the site along Ridge Road

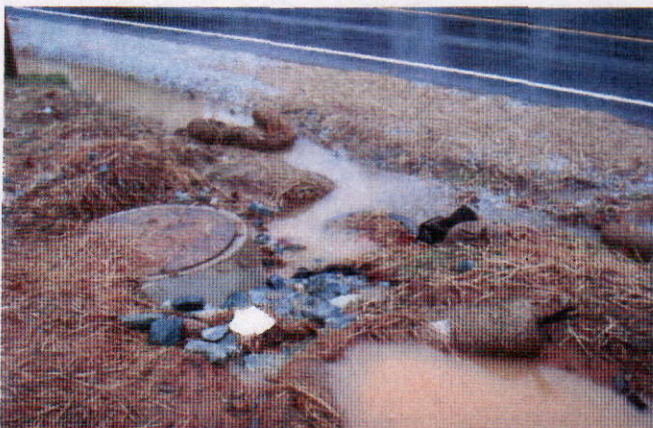
Figure 17: Poorly protected drain inlet along Ridge Road

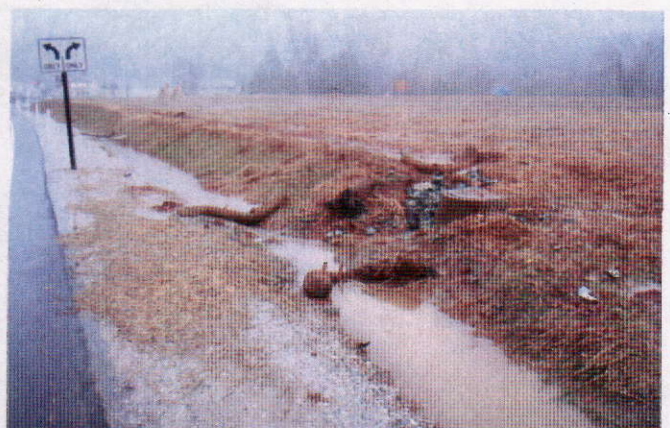
Figure 18: Another view of the poorly protected drain inlet

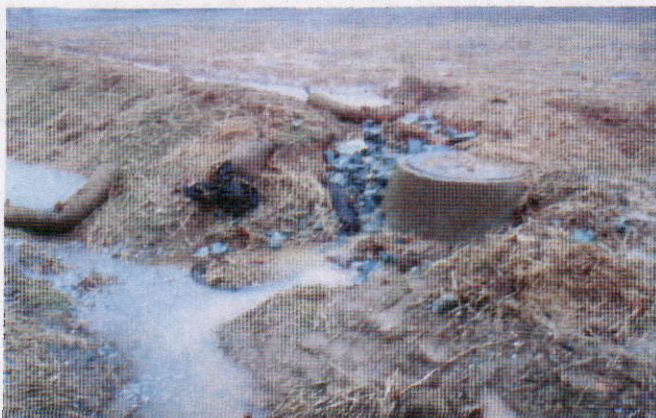
Figure 19: Another view of the same area

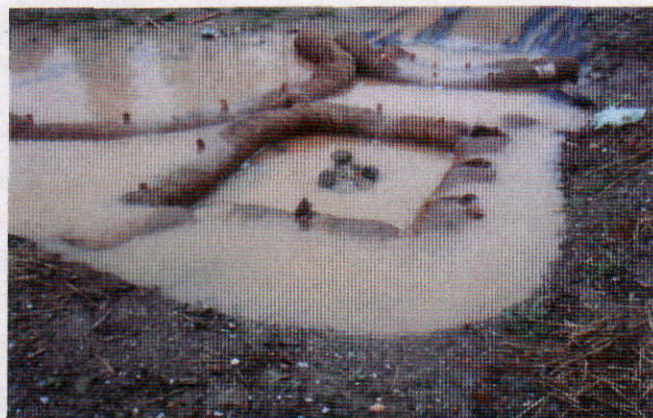
Figure 20: Pondered storm water around another drain inlet

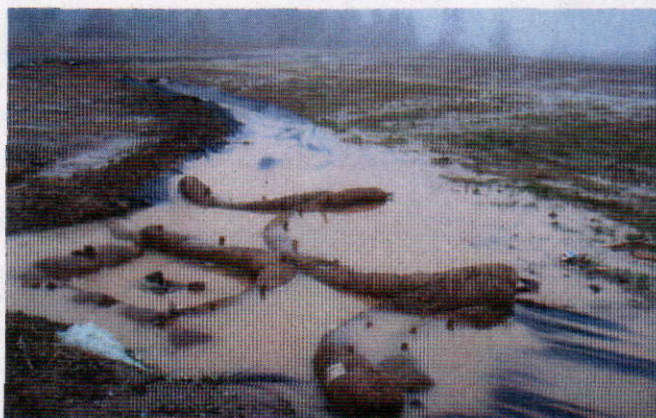
Figure 21: Still another view of the same area

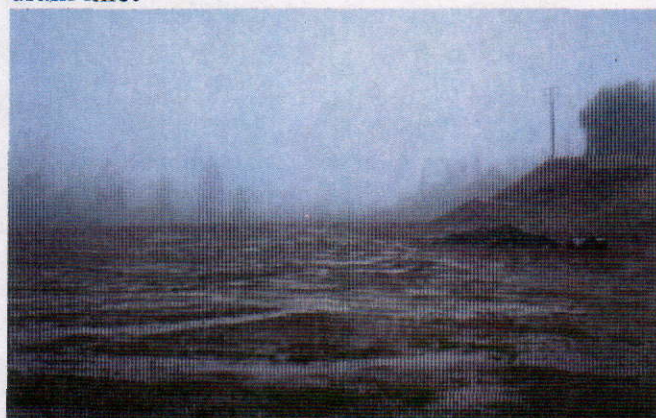
Figure 22: Lack of an effective combination of erosion and sediment control BMPs on another portion of the project

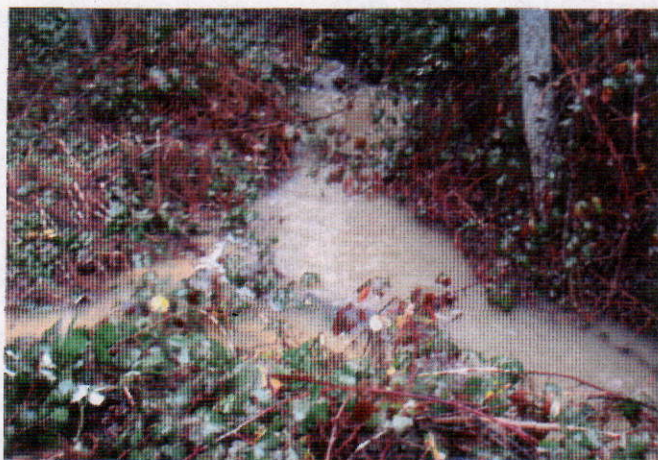
Figure 23: Storm water from the site mixing in the creek at one of the discharge locations Note: the storm water from the site is on the left hand side of the photograph

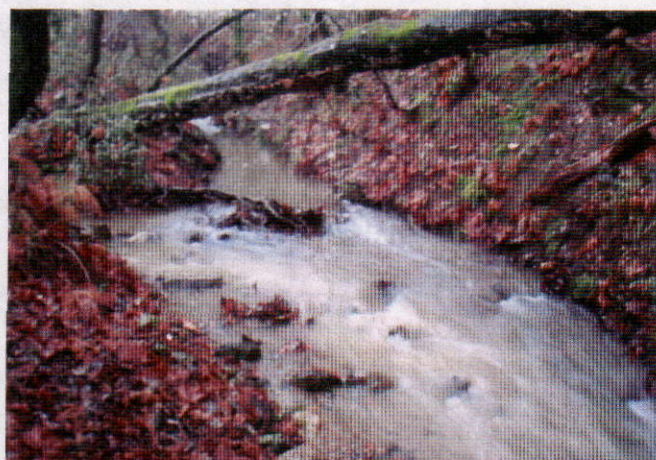
Figure 24: Storm water from the site mixing in the creek at another discharge location Note: the storm water from the site is on the left hand side of the photograph

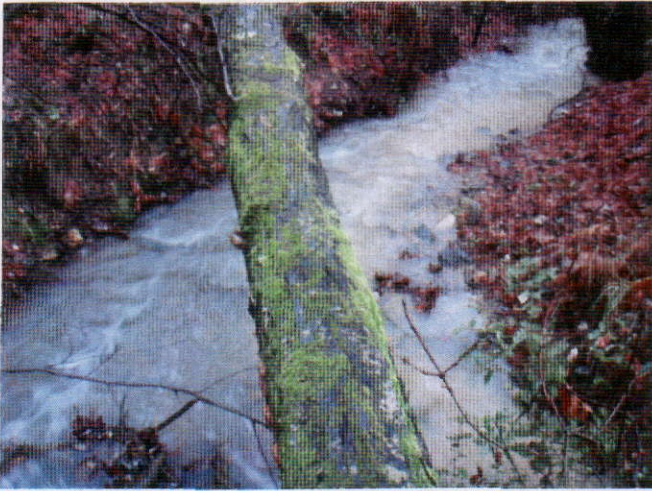
Figure 25: Another view of the same area
